1/4 11 \mathscr{L}^{\sim} Rev. No. Page A Number SUPPORTING DOCUMENT of SD- WM-TI-260 Rev. 0 36 Waste Management Total Pages Document Title: · XXI No Baseline Document ☐ Yes Water Inflow Investigation at the WBS No. or Work Package No. 218-E-12A and 218-E-12B Burial Grounds WA4AA Prepared by (Name, Dept. No. and Signature) R.C. Routson, J.M. Calimann, D.R. Hyers, M.R. Adams, S. P. Luttrell (65630)
See reverse side for additional approvals Ditch Leakage, Perched Water, bentonite, corrective action THE DOCUMENT IS FOR USE IN PERFORMANCE OF WORK UNDER CONTRACTS WITH THE U.S. DEPARTMENT OF ENERGY BY PERSONS OF FOR PURPOSES WITHIN THE SCOPE OF THESE CONTRACTS. DISEMINATION OF ITS CONTENTS FOR ANY OTHER USE OF PURPOSES EXPRESSLY FORBIDDEN Distribution Name Mail Address Department of Energy -Richland Opertaions Office Abstract llevaris FED/625/700 Nater inflow observed in trench 36 in the A. R. Schwankoff FED/625/700 213-E-12B burial ground was feared to occur in a much larger portion of the 218-E-12B burial Rockwell Hanford Operations ground and to possibly extend to the 218-E-12A R. Adams (2) burial ground. Emplacement of investigation 2750E/200E trenches and wells were utilized to demo

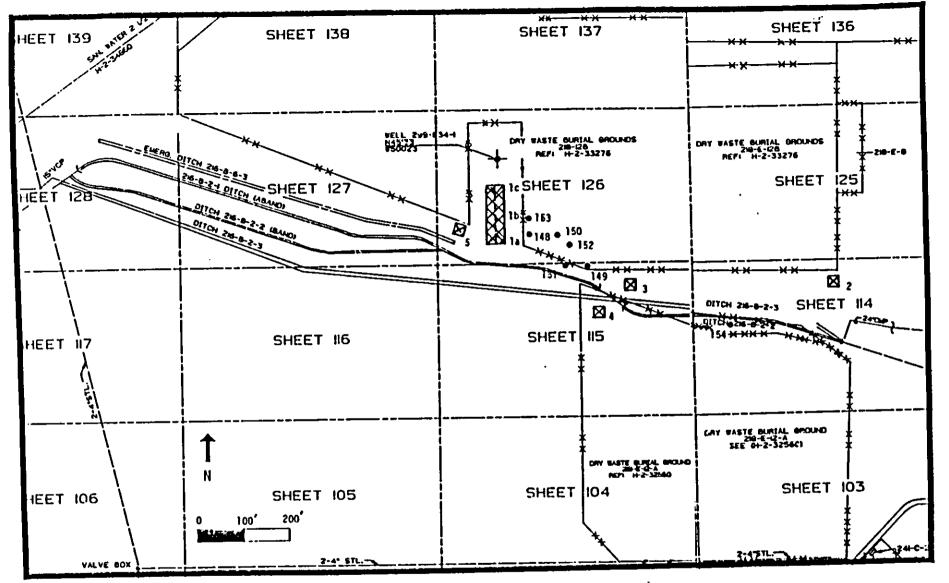
Figure 1: Location of 218-E-12B and 218-E-12A Burial Grounds and 216-B-2-3 Ditch Including Excavation, Trenches, and Well Locations.

Water inflow was observed in unfilled burial trench 36 in the 218-E-128 (E-12B) burial ground (Figure 1 and Figure 2). Water flows into the trench at the 612.5 ft elevation and runs for about 85 ft along the trench bottom before percolating into the sediments. The flow rate has been estimated to be about one gallon per minute but it has not been confirmed.

In addition to the E-12B burial ground, the 218-E-12A (E-12A) burial ground to the south of the B-2-3 ditch and the 218-E-12B expansion area to the west of the E-12B burial ground were considered to have a potential for water inflow (Figure 1). All of these areas are approximately equal

An investigation trench and a borehole were emplaced in the E-12A burial ground to evaluate the extent of water inflow. Investigation trench 4 (Figure 1) which is located on the northwest edge of E-12A burial ground contained no saturated sediments above an elevation of 618 ft. The elevation of the bottom of the nearest burial trench is 624 ft. If the elevation of a burial trench bottom is higher than the saturated elevation no inflow of water is expected. The depth of a burial trench was estimated by subtracting 18 ft from the ground surface elevation at the trench. The burial ground specifications require that the trench depth be 16-18 ft below the surface elevation. Thus the western part of the E-12A burial has received no inflow.

Borehole 299-E27-154 (154, all boreholes are prefixed by 299-E27-) was emplaced on the north edge near the E-12A burial ground's east-west midpoint (Figure 1). No saturated sediments were encountered above an elevation of 613 ft in borehole 154. The elevation of the bottom of the nearest trench is at an elevation of 619 ft. No inflow of water is indicated into the surrounding burial trenches.

Three investigation trenches were emplaced around the E-12B burial ground to determine the potential extent of water inflow. Investigation trench 2 located on the southeastern edge of burial ground E-12B contained no saturated sediments above an elevation of 603 ft (Figure 1). The elevation of the bottom of nearest trench was 604 ft. This is an indication that at least some portion of the eastern part of the E-12B burial ground has no water inflow above the burial trench bottoms.

Investigation trench 5 was emplaced about 110 ft west of investigation trench 1b (Figure 1). Investigation trench 5 contained no saturated sediments above an elevation of 608 ft. This is a strong indication that water conditions found in investigation trenches 1a, 1b, and 1c do not exist for any appreciable distance to the west. Furthermore, the lack of any saturated sediments in trench 5 is a strong indication that the B-2-3 ditch is the source of water inflow to trench 36. Trench 5 would not be expected to lack saturated sediments above 608 ft elevation if the 216-B-63 trench or any of the pipelines to the west were the source of inflow to burial trench 36. The lack of saturated sediments in investigation trench 5 is also an indication that the E-12B expansion area likely contains no water inflow above the bottom of the planned trenches.

A final investigation trench was emplaced to determine how far to the east the inflow affected area might extend in the E-12B burial ground. Investigation trench 3 was emplaced to evaluate if more than the western third of the E-12B burial ground could be affected by water inflow (Figure 1). Investigation trench 3 contained no saturated sediments above an elevation of 616 ft. The elevation of the bottom of the nearest burial trench is 612 ft (burial trench 27). As was demonstrated in investigation trenches 1a, 1b, and 1c the hydraulic gradient drops about five ft per 100 ft from the south to the north in the E-12B burial ground. Investigation trench 3 is about 100 ft south of the nearest E-12B burial trench (trench 27). Thus it is likely that there is no inflow of water into the burial trenches to the east of investigation trench 3. A borehole drilled later in the investigation confirmed that these trenches received no water inflow (149).
